Special Situation Report

U.S. Army Corps of Engineers
Omaha District

Low Dissolved Oxygen Levels in Summer Powerplant Discharges from Fort Randall Dam, South Dakota

Report Number: CENWO-ED-HA/SSR/Fort Randall Tailwaters/2010

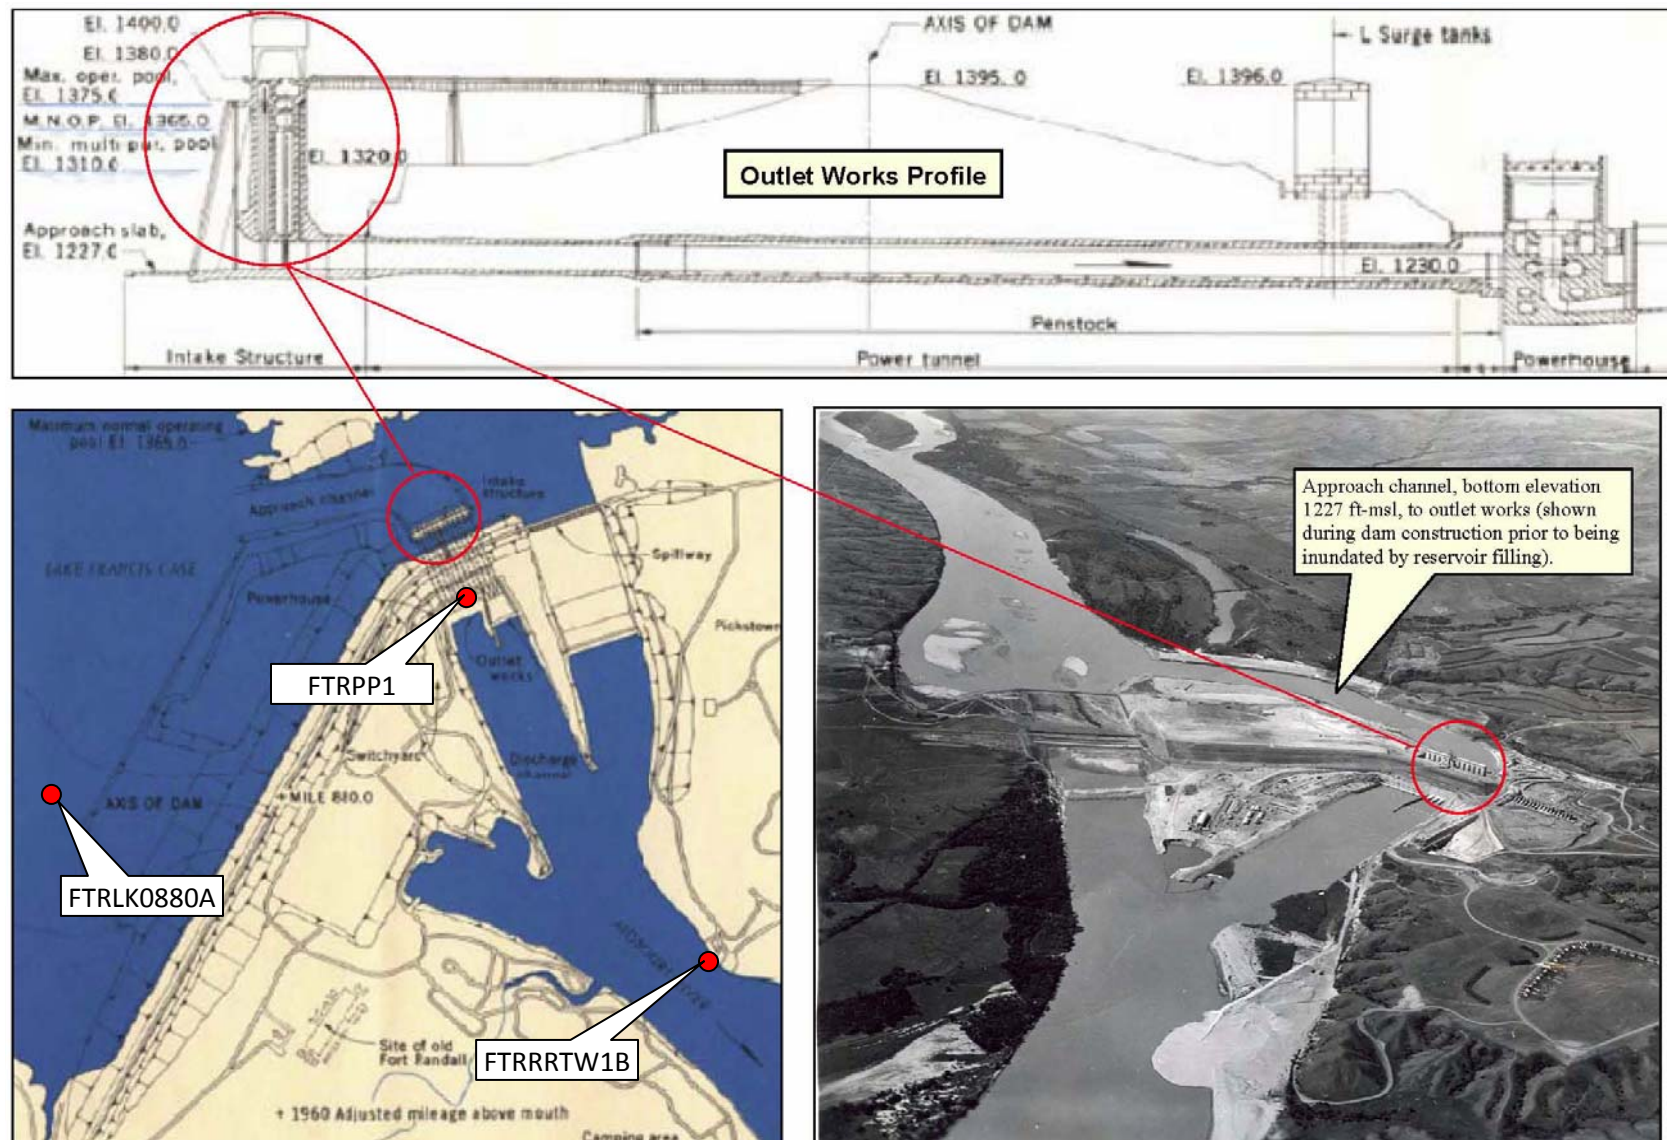
In Lake Francis Case, water is routed to the dam intake structure through a submerged approach channel that connects to the old Missouri River channel (Figure 1). The invert elevation (i.e., 1229 ft-msl) of the intake for the power tunnels at Fort Randall Dam is 2 feet above the bottom of the approach channel. Thermal stratification that develops in Lake Francis Case during the summer results in a significant water density gradient between the epilimnion and hypolimnion. Due to the water density gradient, restricted approach channel, and bottom withdrawal, the vertical extent that water is withdrawn from Lake Francis Case in the summer is dependent upon the discharge rate of the dam. During periods of lower flows through the powerplant water is pulled from lower elevations along the bottom of the reservoir. Higher powerplant flows are believed to create enough “turbulence” near the dam intake structure to allow warmer, less dense water to be drawn from higher elevations in Lake Francis Case.

Figure 1. Schematic drawing and photo of outlet works at Fort Randall Dam. Water quality monitoring sites shown in lower left diagram.

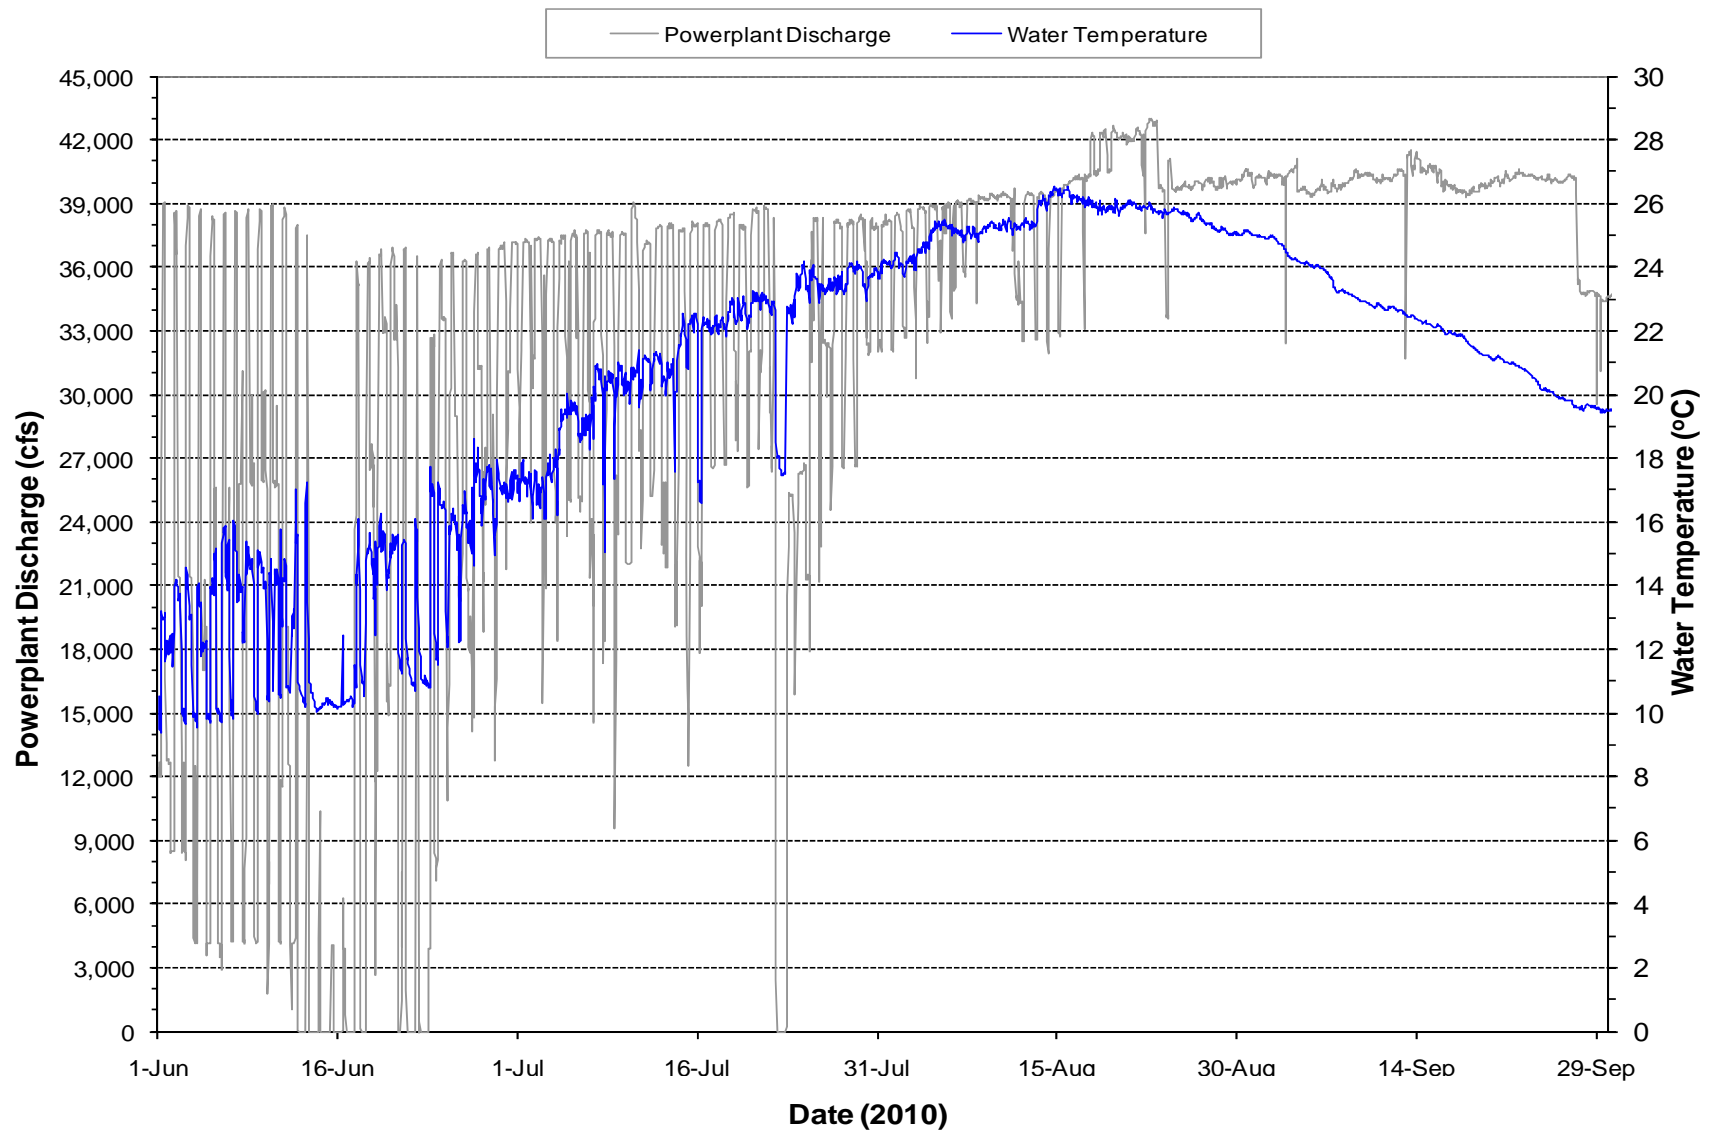
Water quality conditions monitored at the Fort Randall powerplant in 2010 were reviewed. Figures 2 and 3 show hourly water temperature and dissolved oxygen levels monitored from June 1 through September 30, 2010. Figure 4 shows hourly dissolved oxygen and powerplant discharge for the period July 1 through August 30, 2010. As seen in Figures 2 - 4, the monitored water temperature and dissolved oxygen were more dependent on dam discharge in June and July. Dissolved oxygen levels continually decreased during June, and first went below South Dakota's 5 mg/l dissolved oxygen water quality standard minimum criterion on July 8. The lowest dissolved oxygen occurrences tend to be associated with lower dam discharges.

Figure 2. Hourly powerplant discharge and water temperature monitored in the Fort Randall powerplant “raw water” supply line during the period June 1 through September 30, 2010.

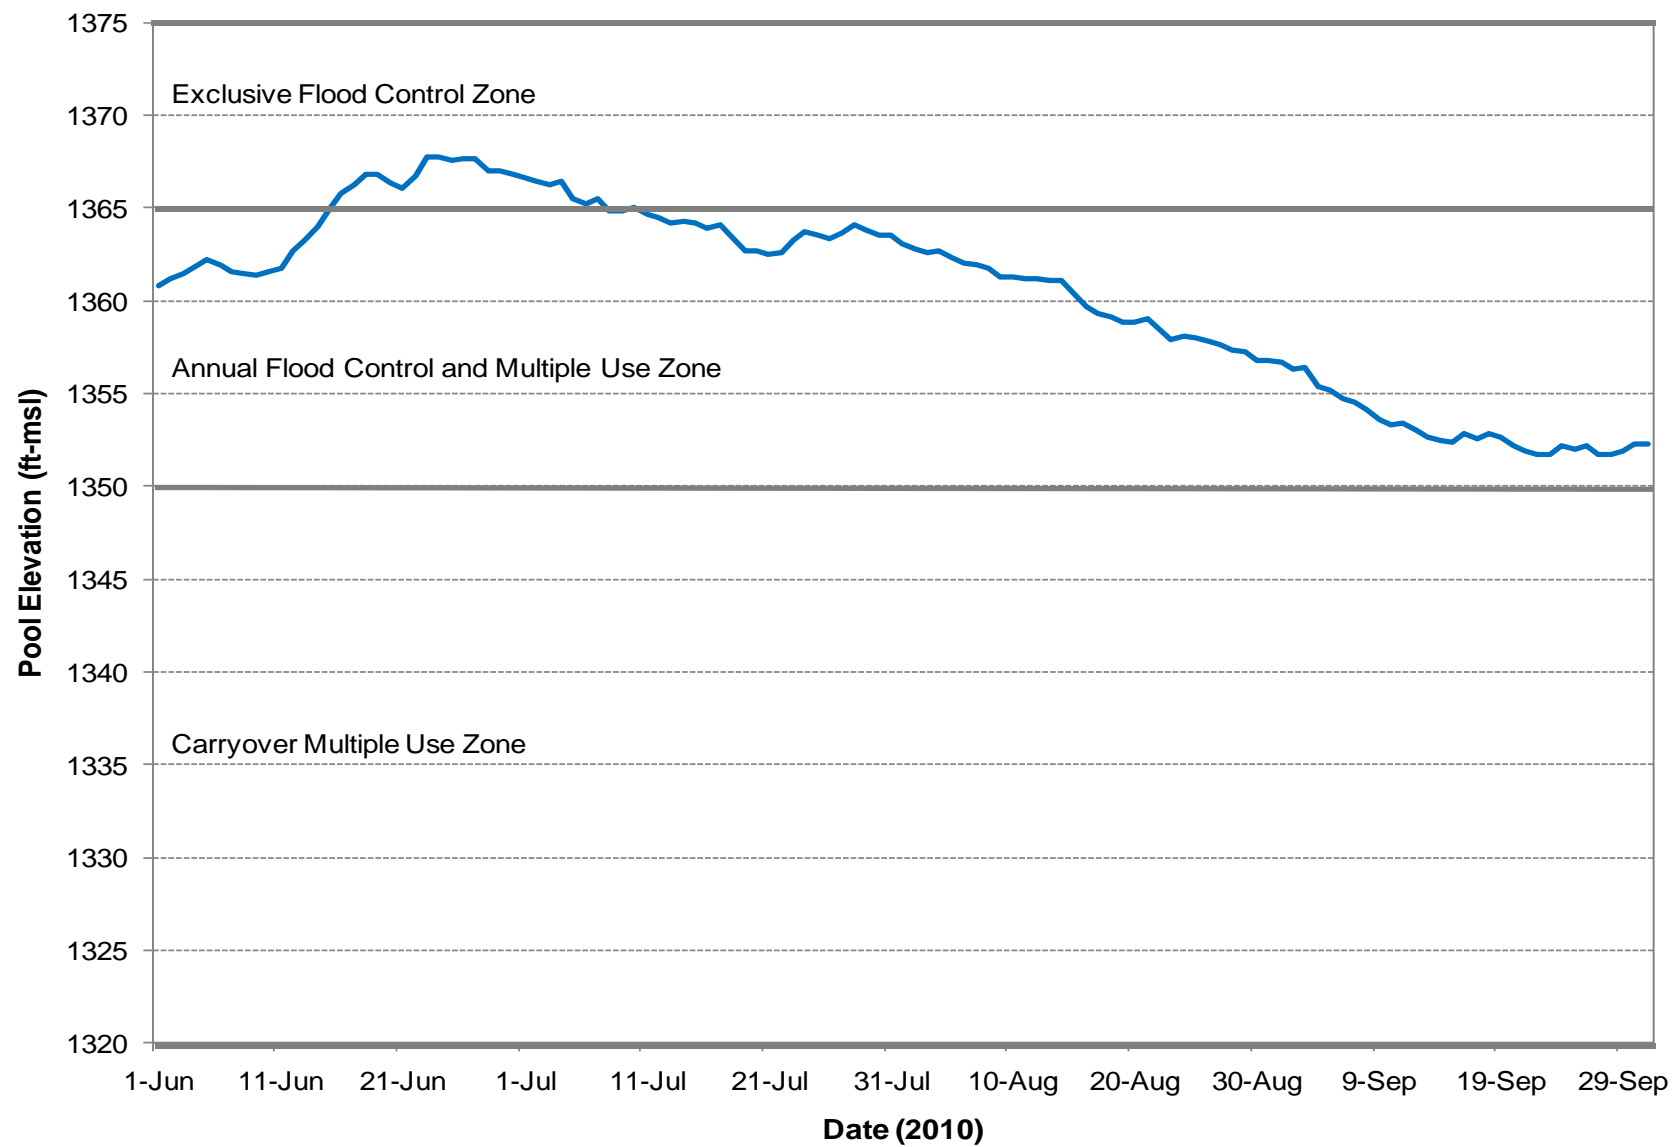
Figure 5 plots the midnight pool elevations for Lake Francis Case from 1-June-2010 through 1-October-2010. Pool levels in Lake Francis Case peaked in late-June (Figure 5). Higher pool levels in Lake Francis Case enforce summer thermal stratification of the reservoir and an increased hypolimnetic volume. Decreasing pool levels will enhance mixing of the reservoir. Mixing of the reservoir will lead to the breakdown of thermal stratification and eventual "re-aeration" of the lower depths of the reservoir.

Figure 5. Lake Francis Case midnight pool levels June 1 through October 1, 2010.

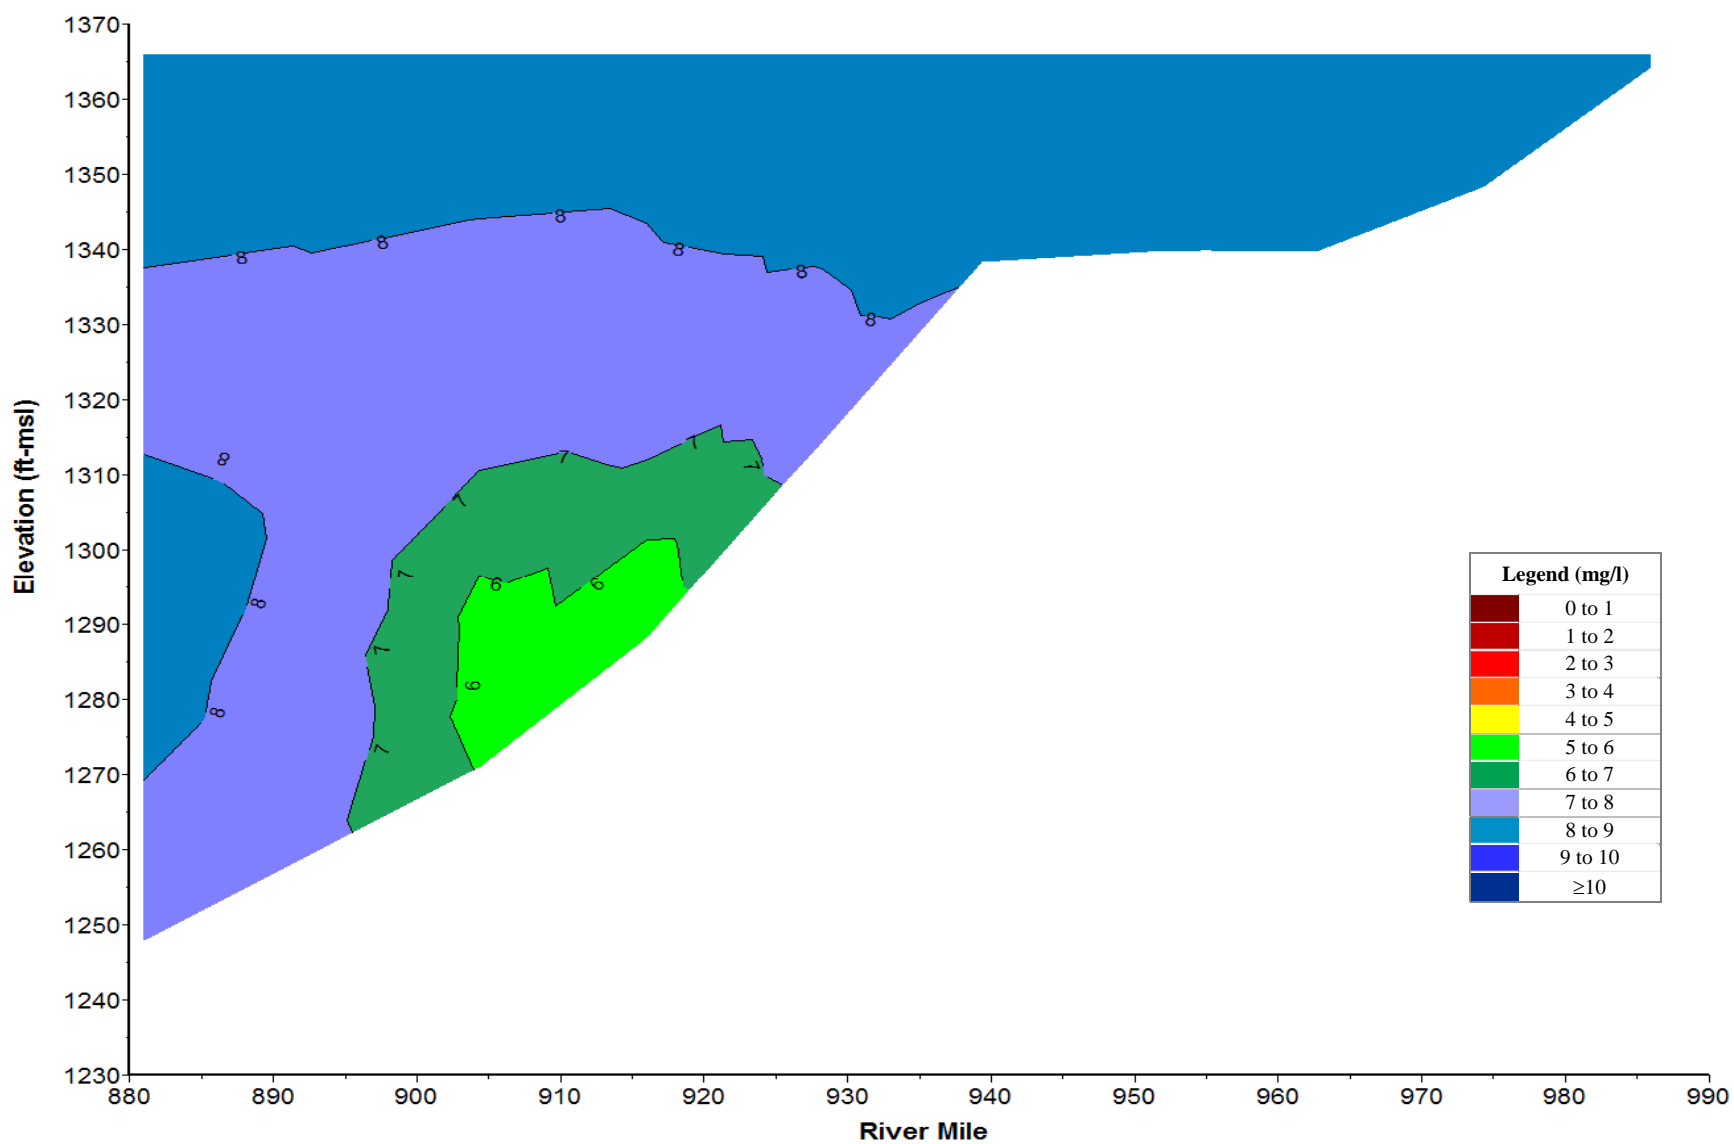
Water quality monitoring of the ambient monitoring sites on Lake Francis Case occurred on June 17, 2010. Longitudinal contour plots of water temperature and dissolved oxygen were constructed from depth-profile data collected at RM880, RM911, RM940, and RM968. Figures 7 and 8, respectively, show the longitudinal contour plots for water temperature and dissolved oxygen. On June 17, Lake Francis Case was thermally stratified and a distinct hypolimnion had

Figure 8. Longitudinal dissolved oxygen contour plot of Lake Francis Case based on depth-profile dissolved oxygen levels measured at RM880, RM911, RM 940, and RM968 on June 17, 2010.

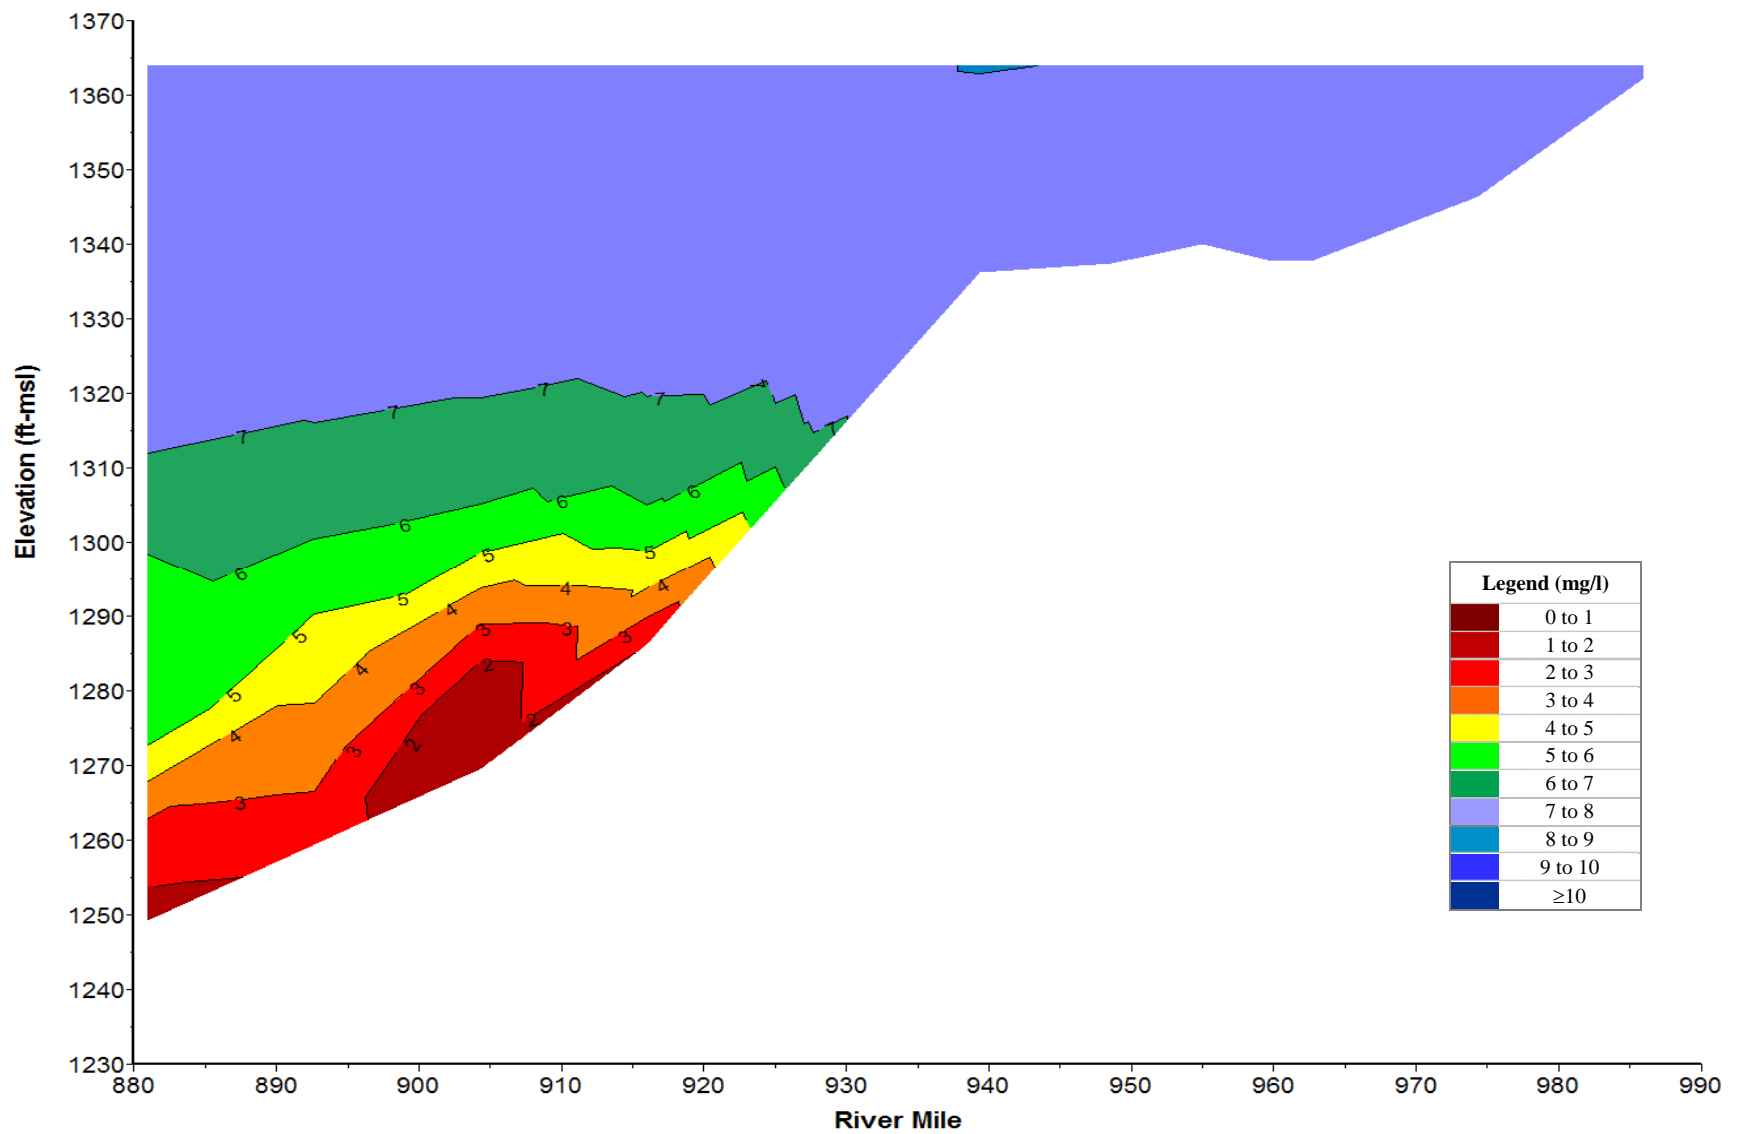
Water quality monitoring of the ambient monitoring sites on Lake Francis Case occurred on July 15, 2010. Longitudinal contour plots of water temperature and dissolved oxygen were constructed from depth-profile data collected at RM880, RM911, RM940, and RM968. Figures 9 and 10, respectively, show the longitudinal contour plots for water temperature and dissolved oxygen. On July 15, Lake Francis Case was thermally stratified and the thermocline was located at about elevation 1285 ft-msl at a depth of about 25 meters (Figure 9).

Figure 10. Longitudinal dissolved oxygen contour plot of Lake Francis Case based on depth-profile dissolved oxygen levels measured at RM880, RM911, RM 940, and RM968 on July 15, 2010.

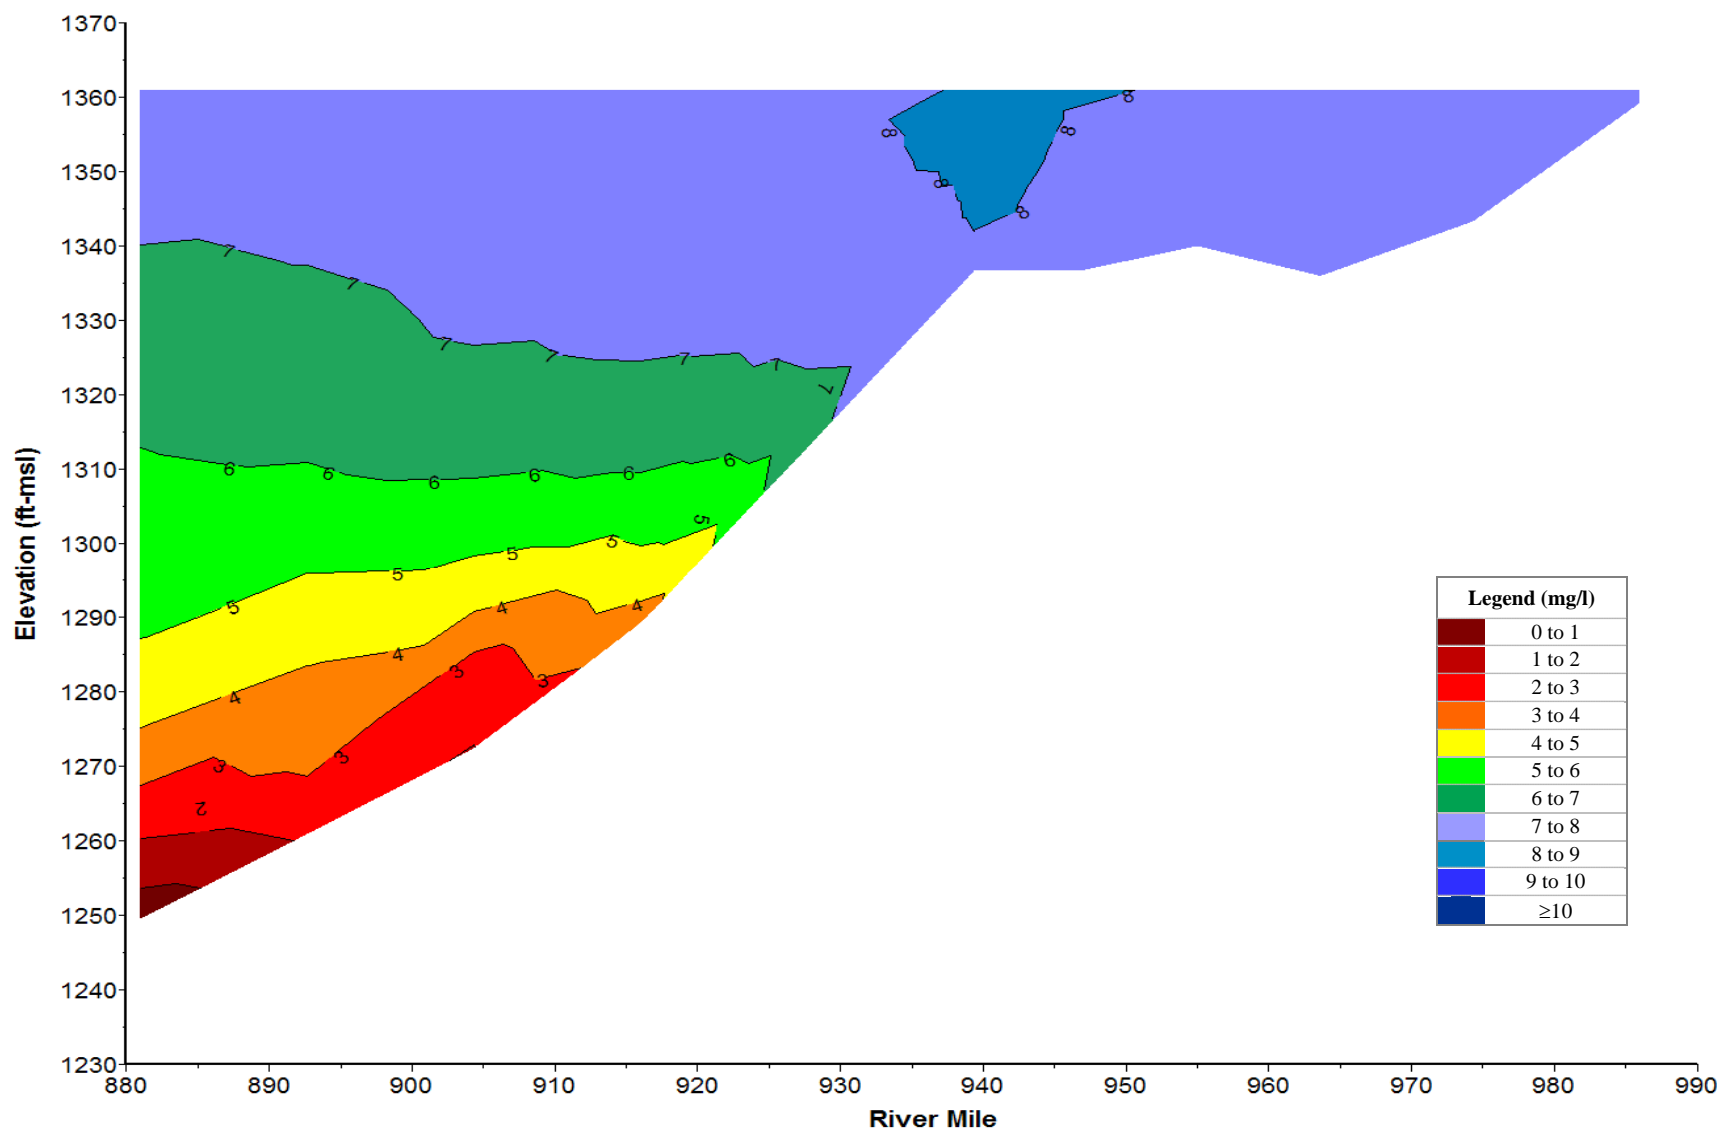
During the summer of 2010, dissolved oxygen conditions in Lake Francis Case varied longitudinally from the dam to the reservoir’s upstream reaches and vertically from the reservoir surface to the bottom. An area of low dissolved oxygen (i.e., <5 mg/l) was first monitored in July and occurred along the reservoir bottom from the dam upstream to RM925 (Figure 10). A similar area of low dissolved oxygen was again monitored in August, with the most hypoxic water located along the reservoir bottom near the dam (Figure 12). The area of low dissolved oxygen had dissipated when monitored in mid-September, ostensibly with the occurrence of “fall turnover.” The lowest dissolved oxygen concentration measured near the reservoir bottom on June 17, July 15, and August 12, were, respectively, 5.5, 1.6, and 0.4 mg/l.

Figure 12. Longitudinal dissolved oxygen contour plot of Lake Francis Case based on depth-profile dissolved oxygen levels measured at RM880, RM911, RM 940, and RM968 on August 12, 2010.

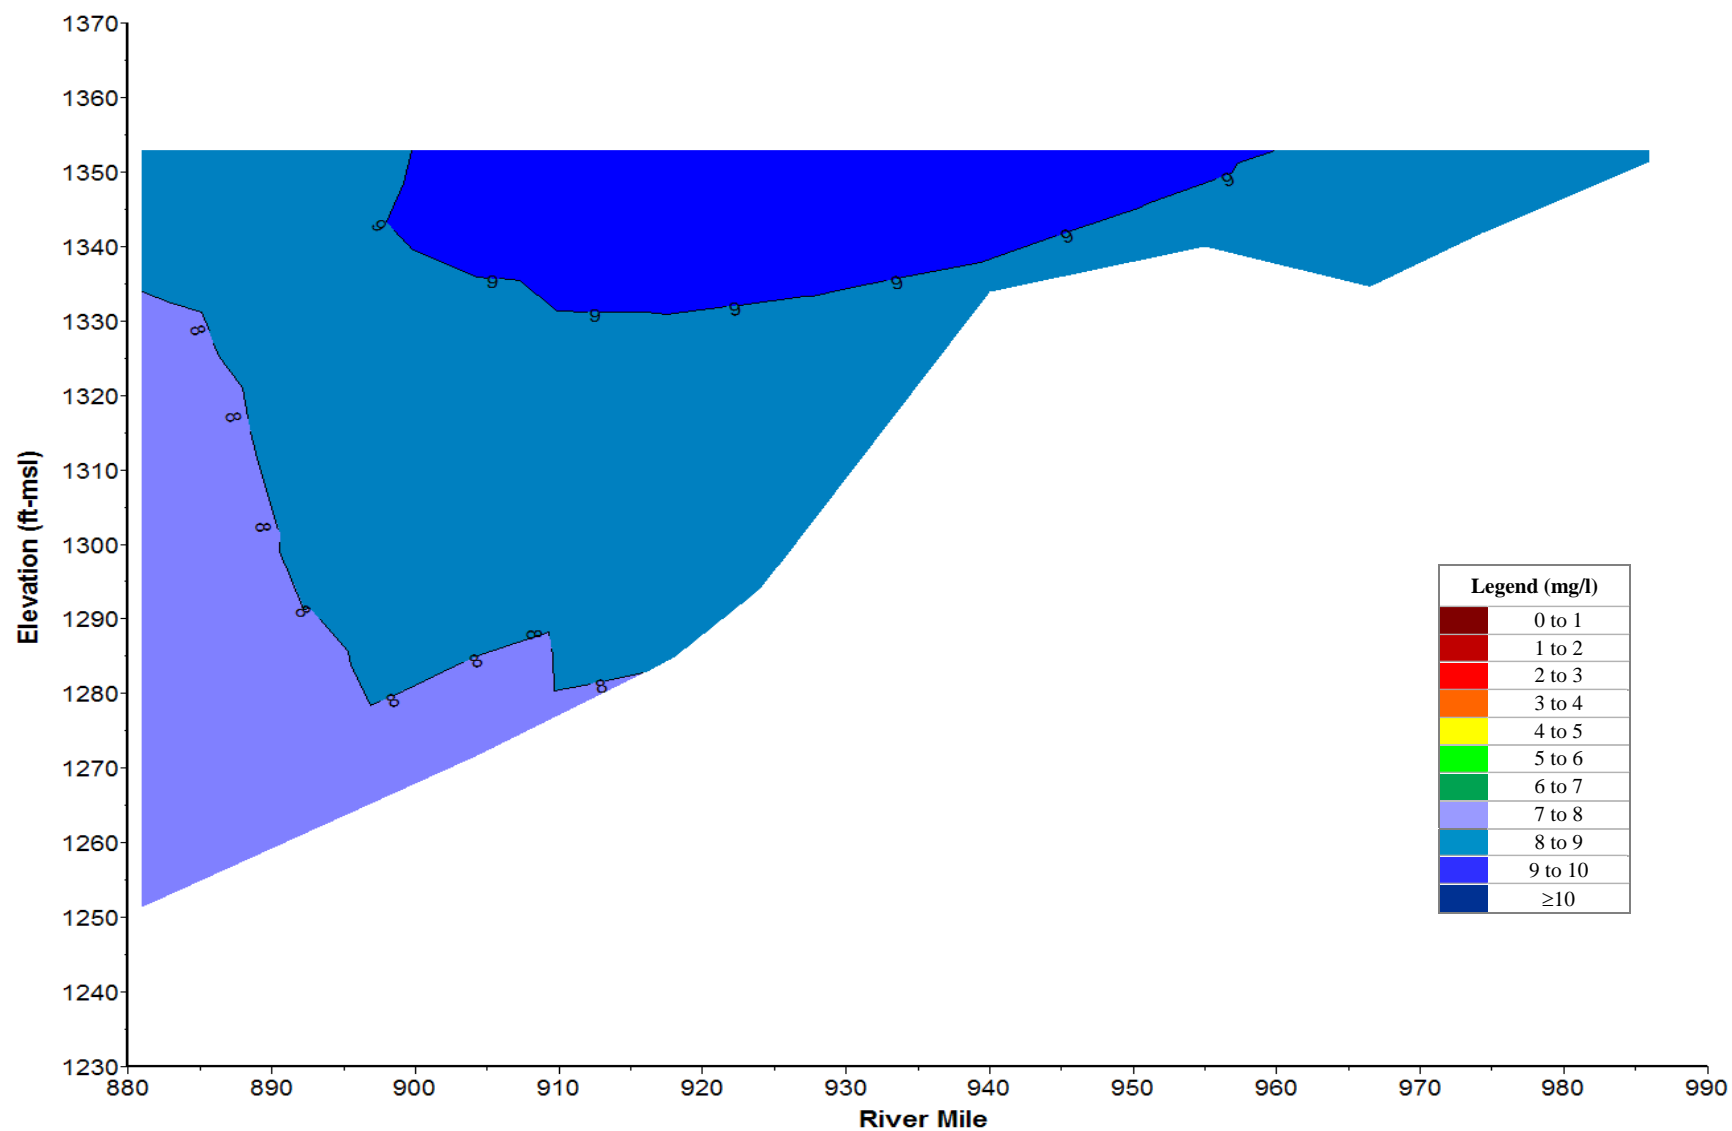
Water quality monitoring of the ambient monitoring sites on Lake Francis Case occurred on September 16, 2010. Longitudinal contour plots of water temperature and dissolved oxygen were constructed from depth-profile data collected at RM880, RM911, and RM968 on September 16. Monitoring at RM940 was not conducted because of an unusable boat ramp due to siltation and low water conditions. Figures 13 and 14, respectively, show the longitudinal contour plots for water temperature and dissolved oxygen. On September 16, Lake Francis Case was no longer thermally stratified (Figure 13).

Figure 14. Longitudinal dissolved oxygen contour plot of Lake Francis Case based on depth-profile dissolved oxygen levels measured at RM880, RM911, and RM968 on September 16, 2010.

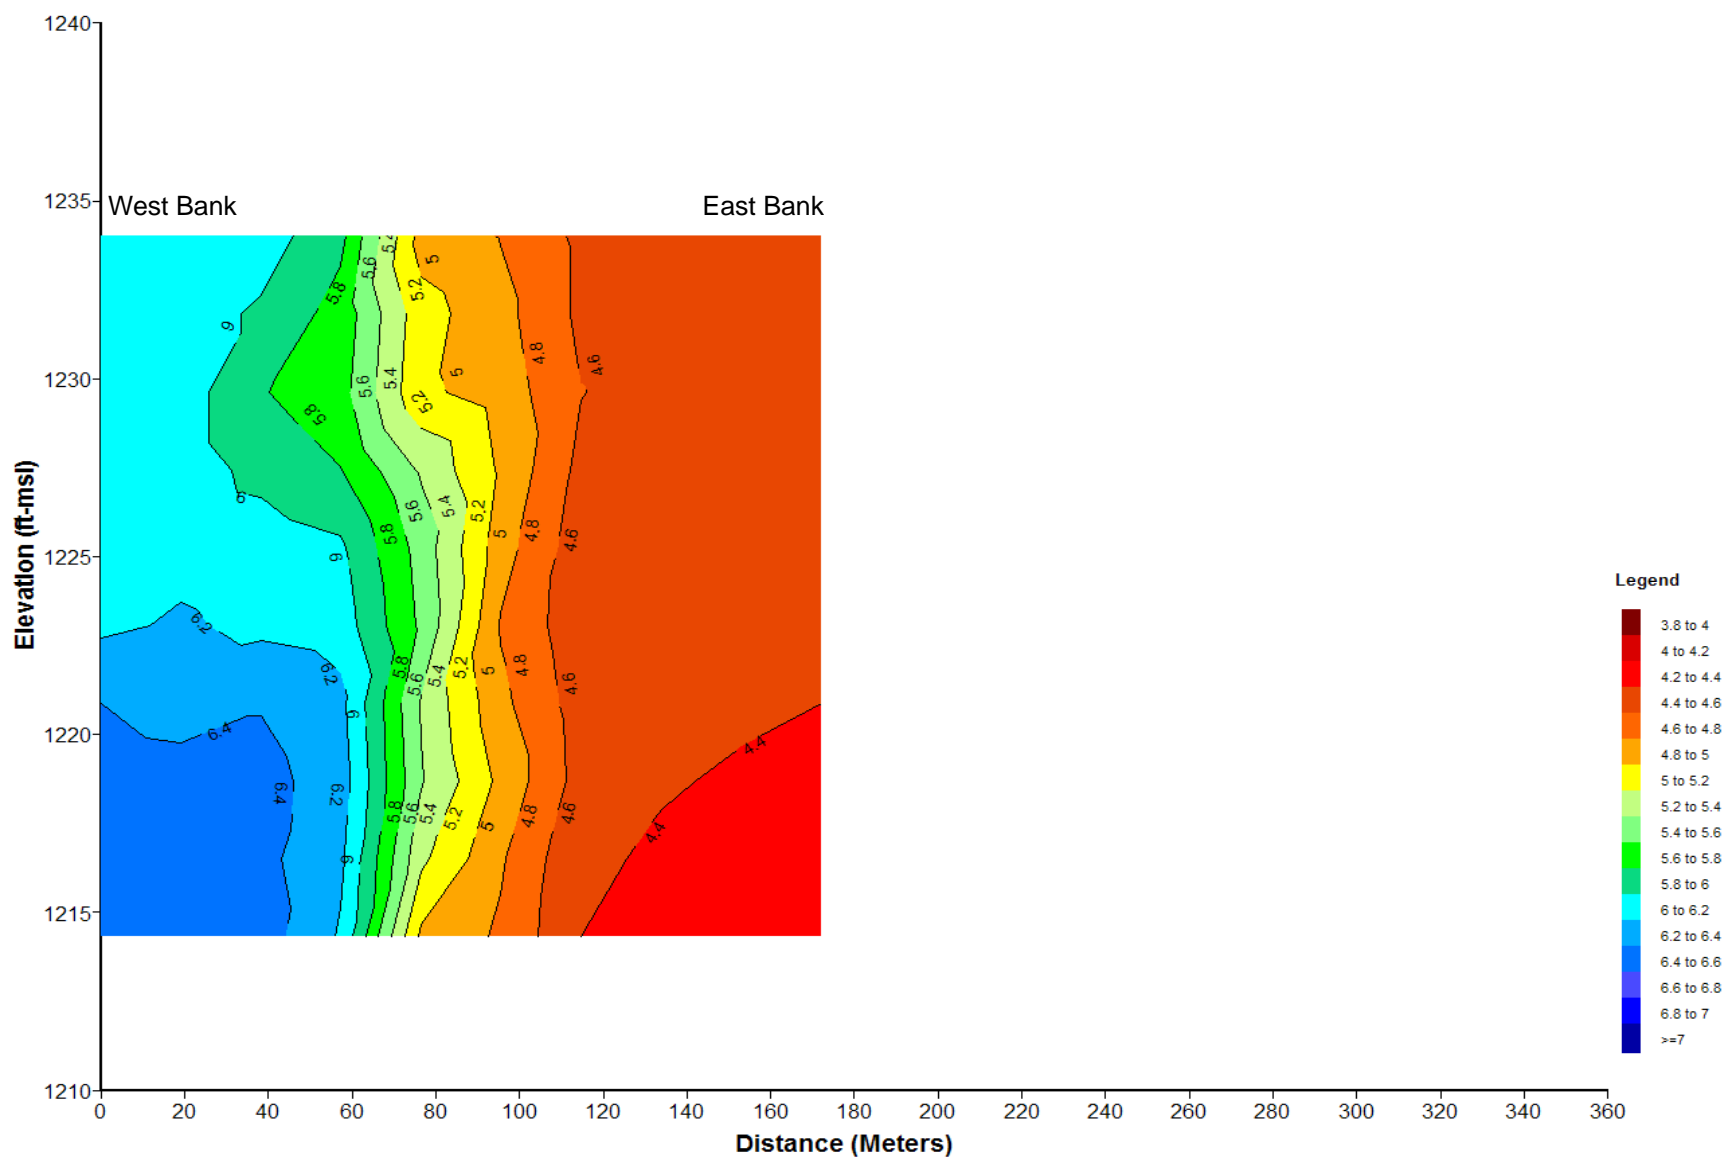
Figures 31, 32, and 33, respectively, display transect contour plots that were constructed to depict the dissolved oxygen concentrations measured across the Fort Randall Dam tailwaters at the near-dam (FTRTW3), spillway confluence (FTRTW2), and downstream (FTRTW1) sites on 10-August-2010. Figure 34 displays an aerial contour plot of the water-column average dissolved oxygen concentrations in the tailwaters based on the 1-meter incremental depth-profile measurements.

Figure 31. Contour plot depicting dissolved oxygen concentrations measured across the near-dam transect (FTRTW3) on August 10, 2010.

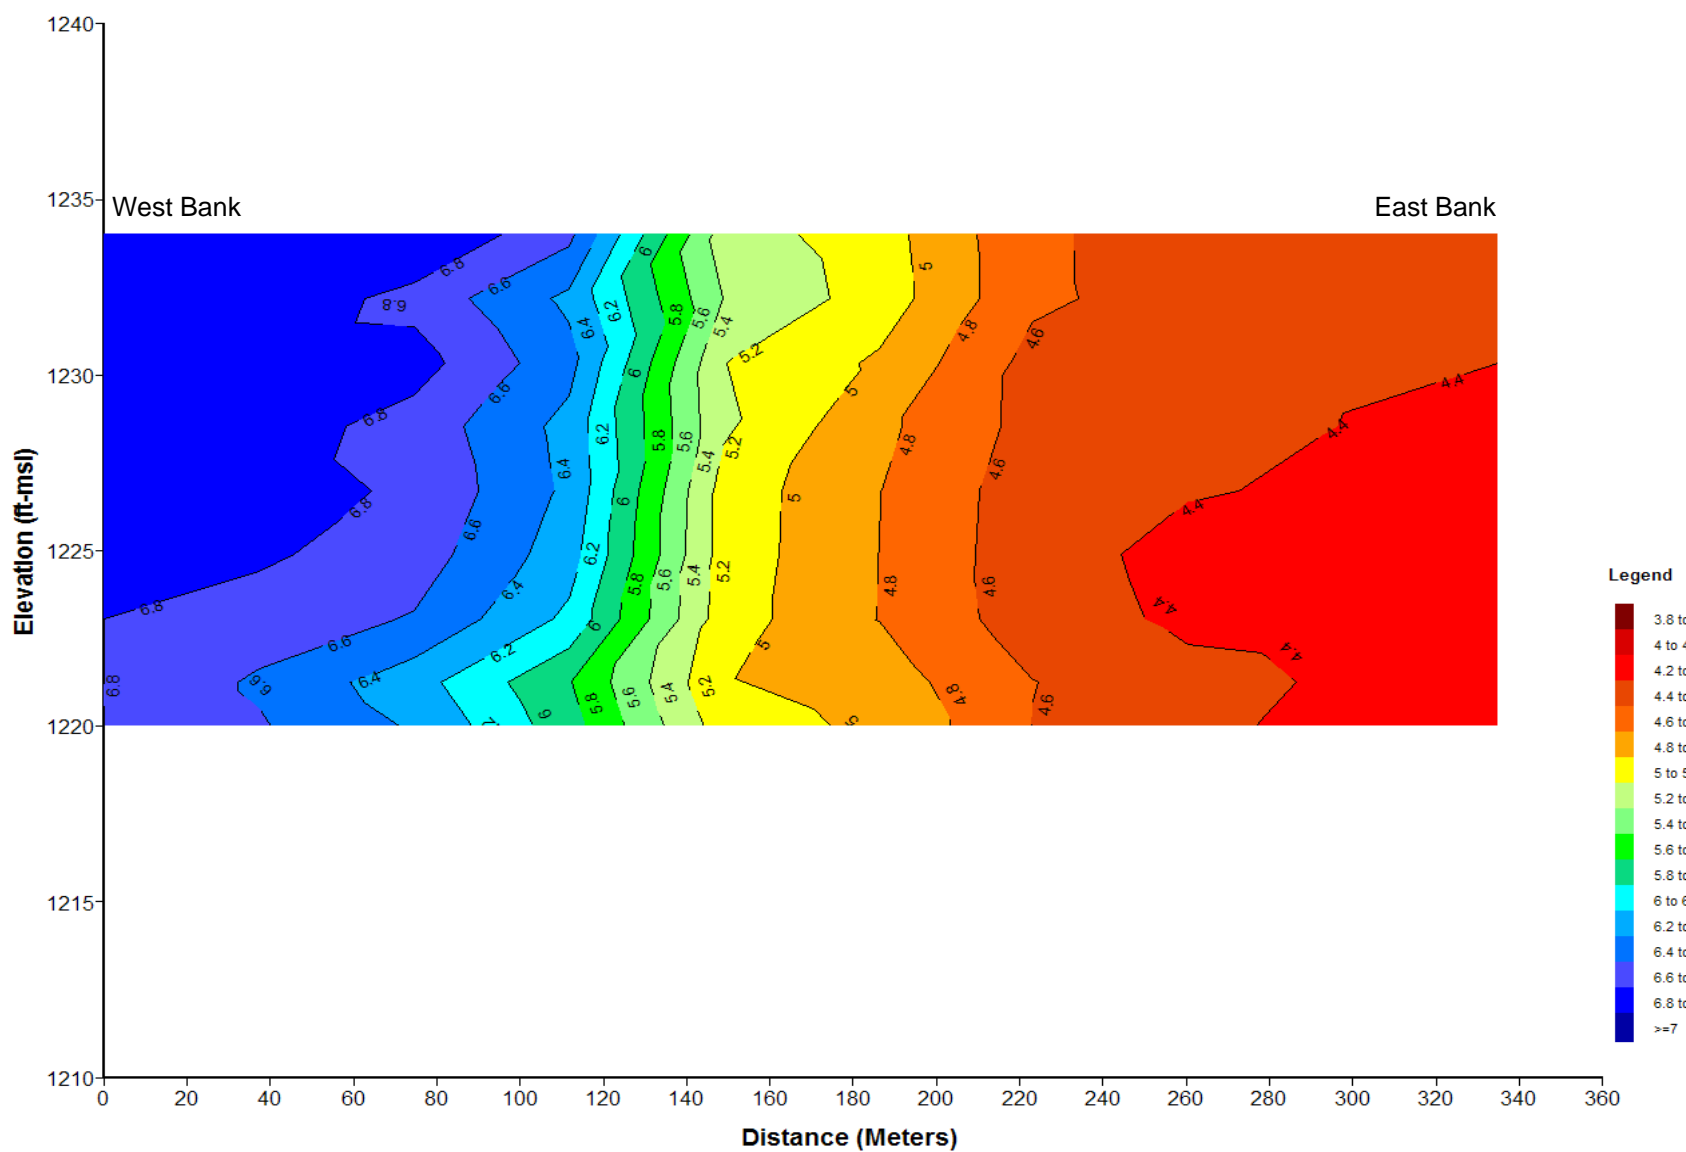
Figure 32. Contour plot depicting dissolved oxygen concentrations measured across the spillway transect (FTRTW2) on August 10, 2010.

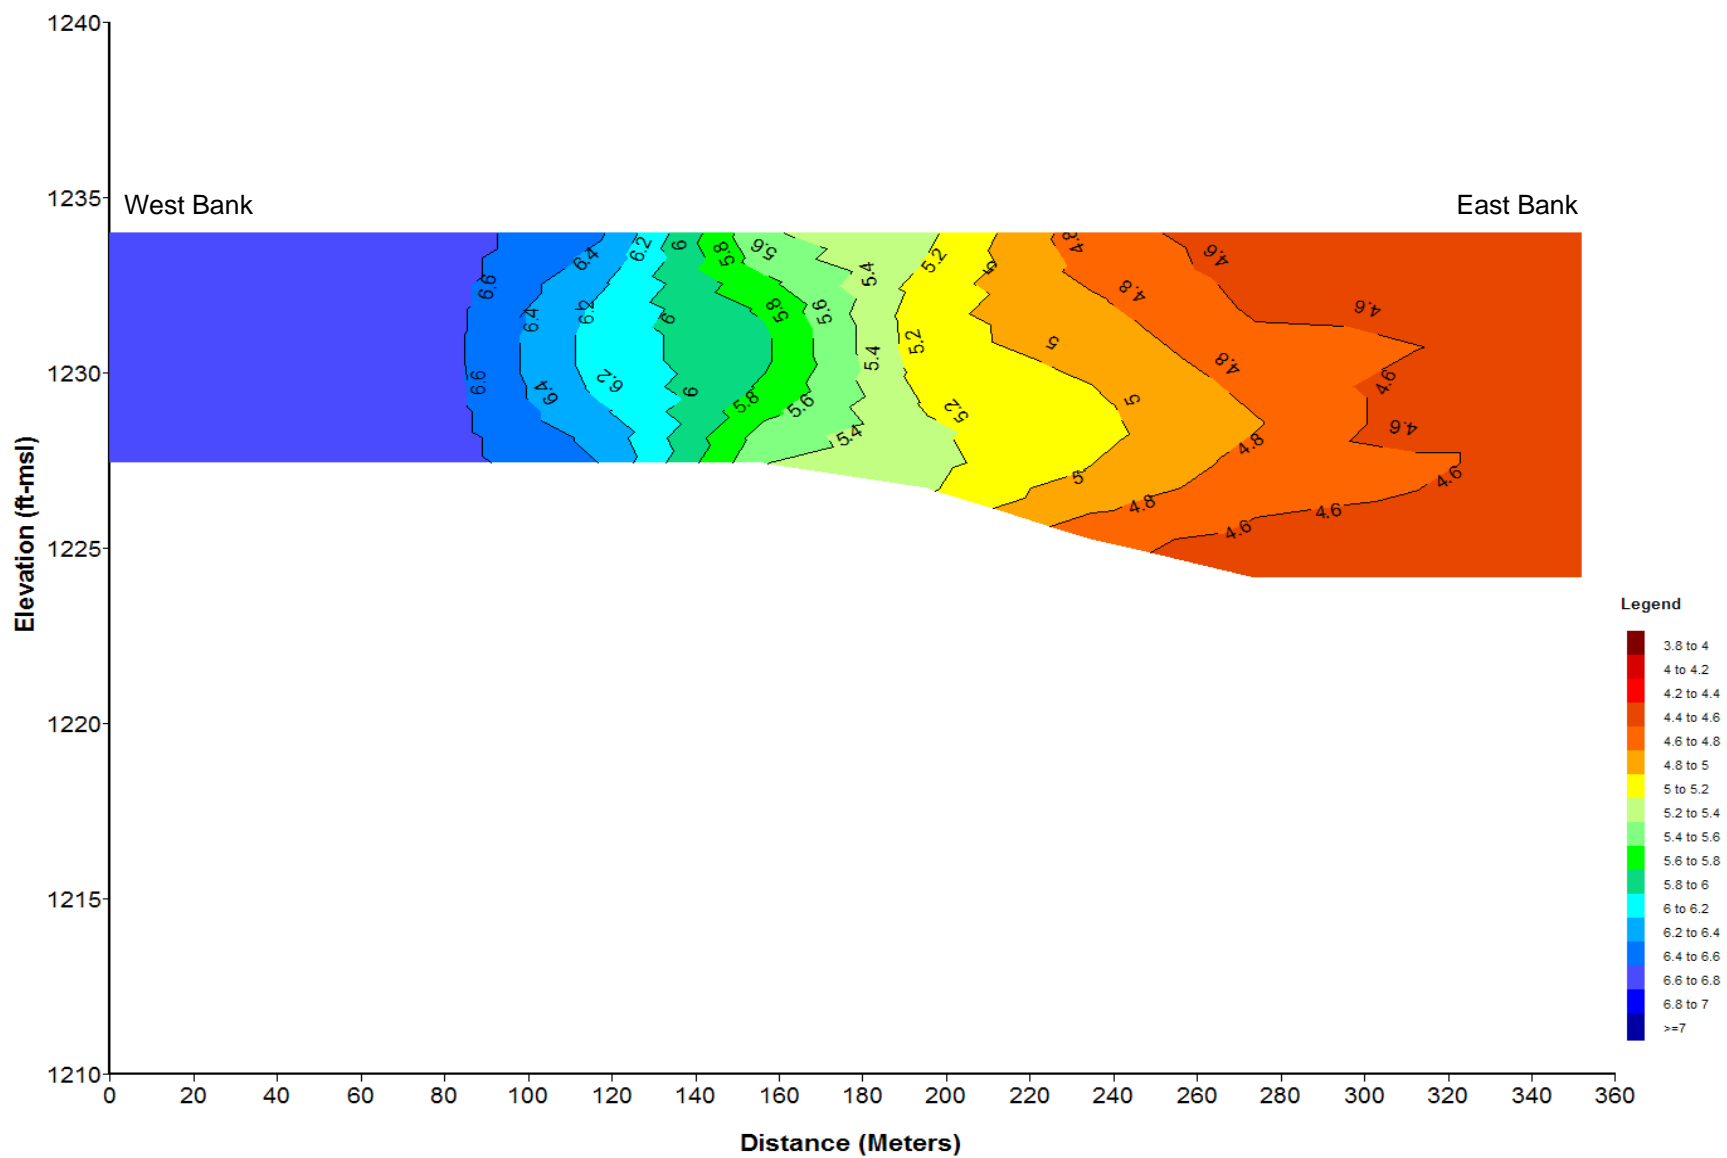
Figure 33. Contour plot depicting dissolved oxygen concentrations measured across the downstream transect (FTRTW1) on August 10, 2010.
